IMPACT-ECHO TESTS ON CONCRETE BRIDGE

BEAM SPECIMEN

Dr. Camilla Colla, Gerhard Schneider, Dr. Herbert Wiggenhauser
Federal Institute for Materials Research and Testing, Berlin, Germany

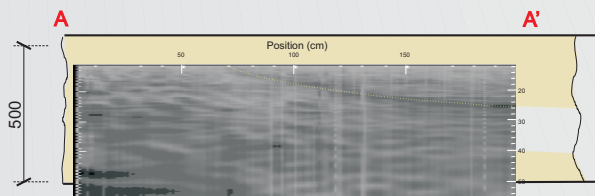
This 2-m long **scan along A-A'** shows the profile of one cavity as a curve instead of a horizontal straight line, as it should have been, indicating a shift of the cardboard formwork. The reflection from the underside of the beam is visible on the left of the image, where the cavities are not present.

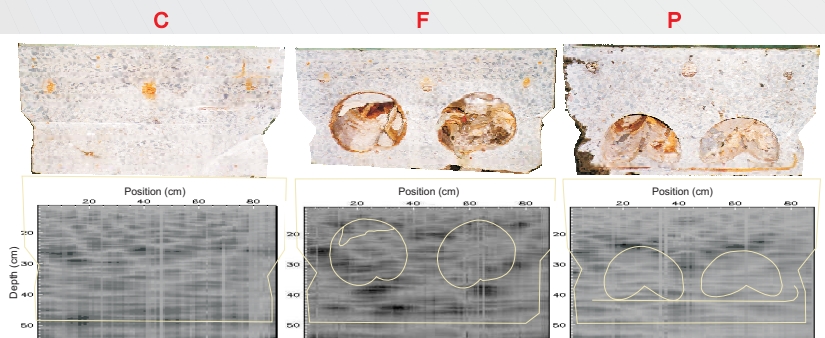
The vertical transversal section at measurement **line C** shows the reflection from the beam's underside at 50-cm depth.

The IE transversal section along **line F** shows the top of the two cavities at 15 cm depth (for the left cavity) and 17 cm (right cavity). The wave velocity is 4000 m/s.

Along measurement **line P**, the top of the 2 cavities is visible at 24.5 cm and 25.4 cm depth. The reflection from the underside of the beam was here not detectable.
