IMPACT-ECHO TESTS ON CONCRETE BRIDGE

BEAM SPECIMEN

Dr. Camilla Colla, Gerhard Schneider, Dr. Herbert Wiggenhauser
Federal Institute for Materials Research and Testing, Berlin, Germany

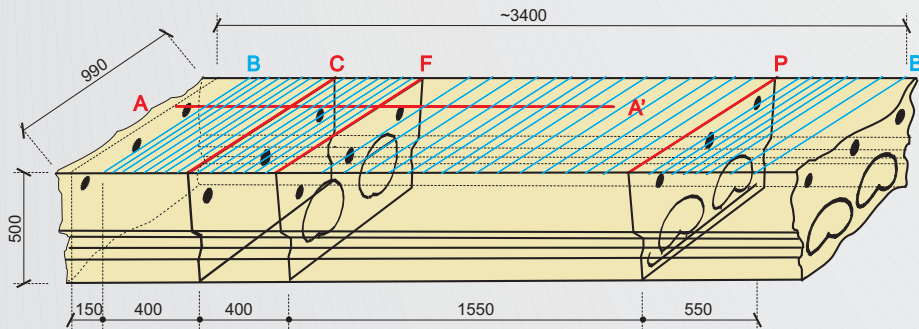
TESTING: a 3.4-m long beam section was cut out from a demolished bridge and tested from the underside. Transversal measurement lines were made up of 88 points, 1-cm spaced. Longitudinal measurement lines run along the two cavities. Data are plotted as 2-D images of depth vs. position on the concrete. Dark grey tones represent stronger signal amplitude.
